Thermal Control System Corrosion Study

Robert Yee, Rolfe A. Folsom, and Phillip E. Mucha

February 1990

Robert Yee, Rolfe A. Folsom, and Phillip E. Mucha
Ames Research Center, Moffett Field, California

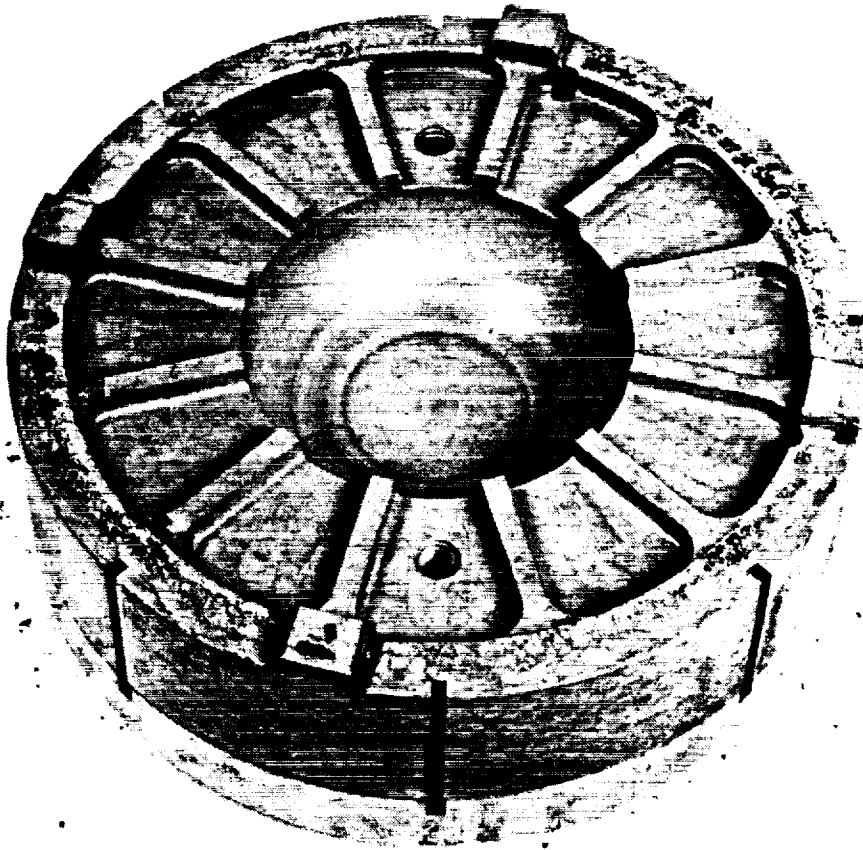
The thermal barrier (figs. 7 [-124] and 22), which is constructed from polyetheretherketone (PEEK), was contaminated but showed no sign of degradation. Other stainless steel components such as the pitots (figs. 7 [-99, -100, -155], 23 through 25) and the other housing (figs. 7 [-9], 26, and 27) were contaminated but showed no sign of corrosion.

Figure 22.- Thermal barrier (-124).

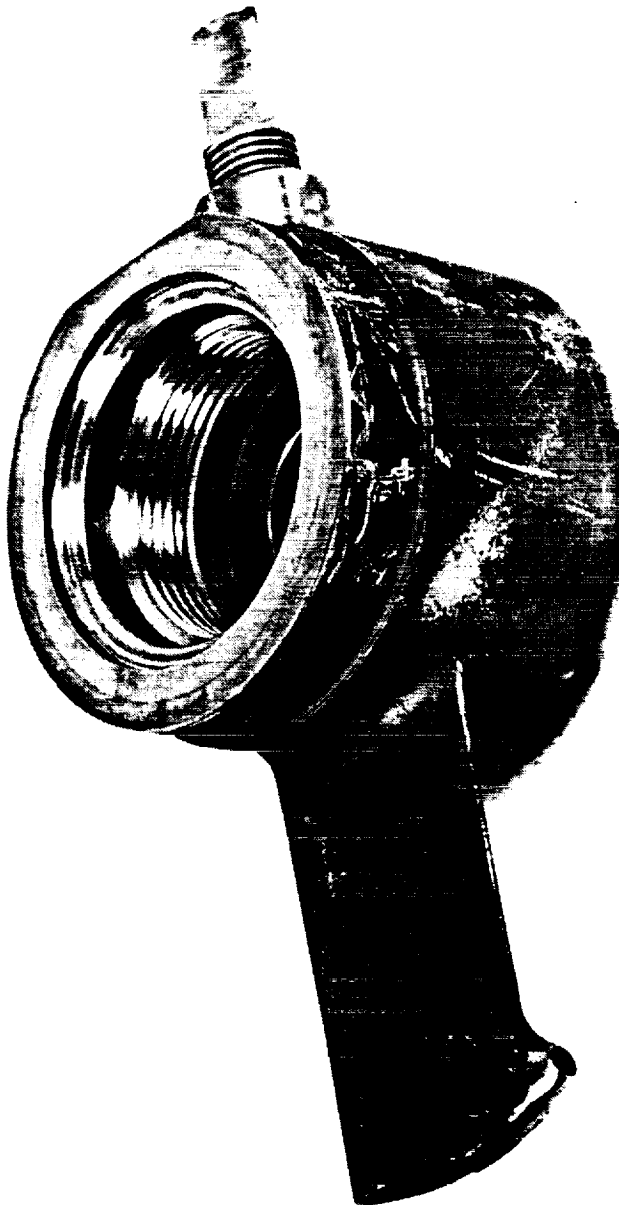
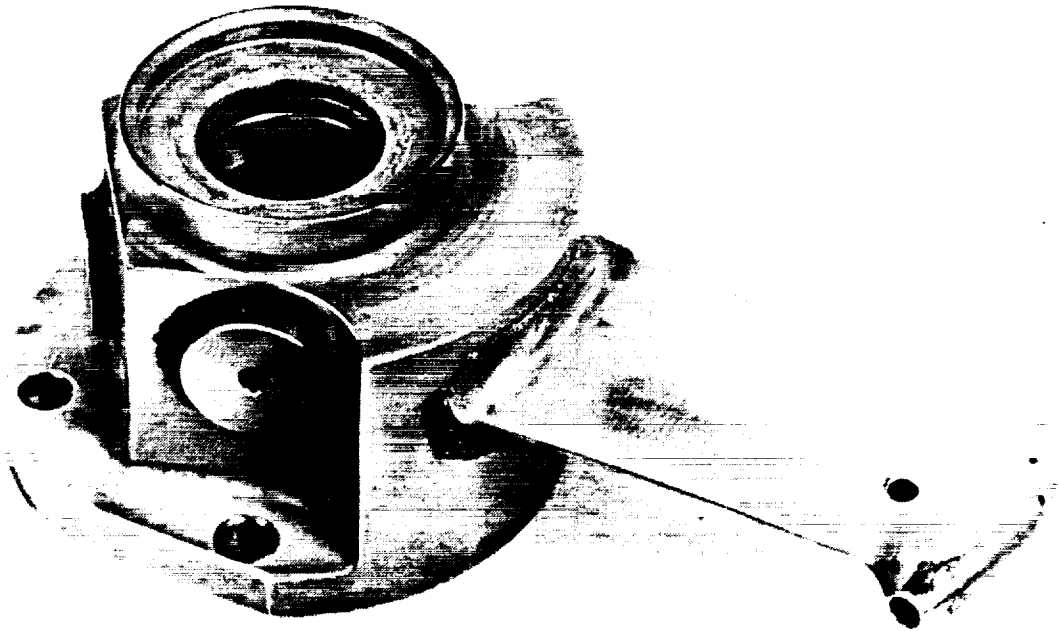
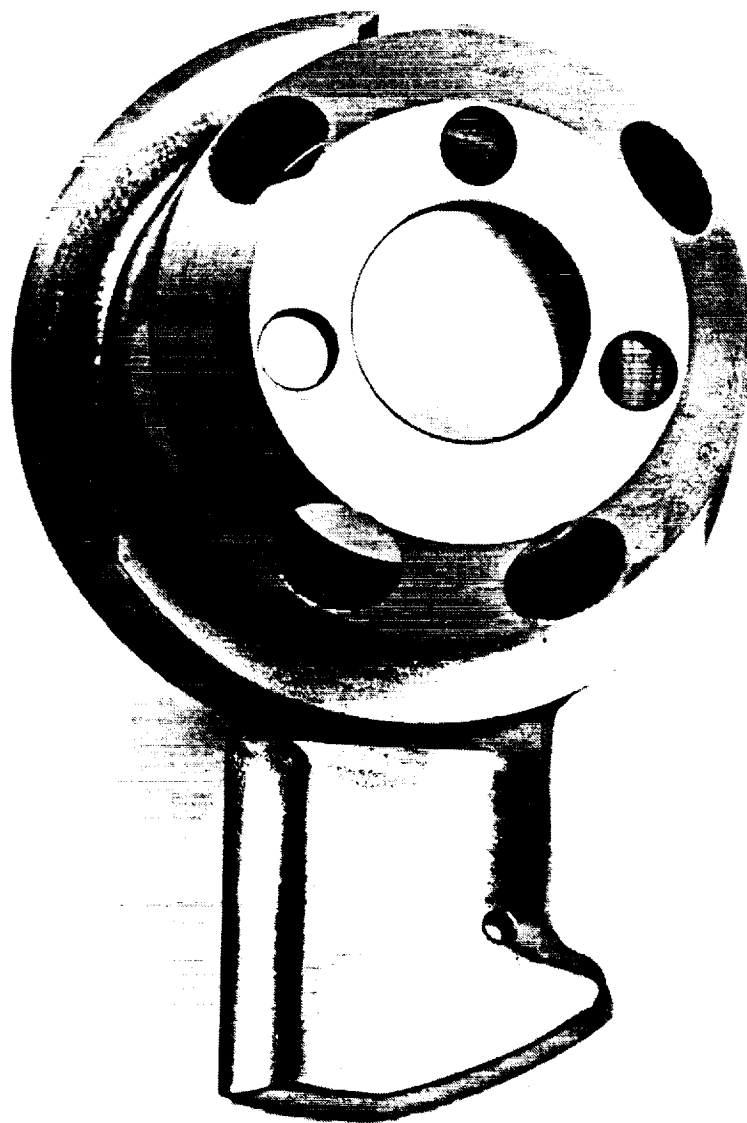
Figure 23.- Evaporator pitot (-100) and level probe (-99).

Figure 24.- Resaturation pitot (-100).

Figure 25.- Recirculation pitot (-155).

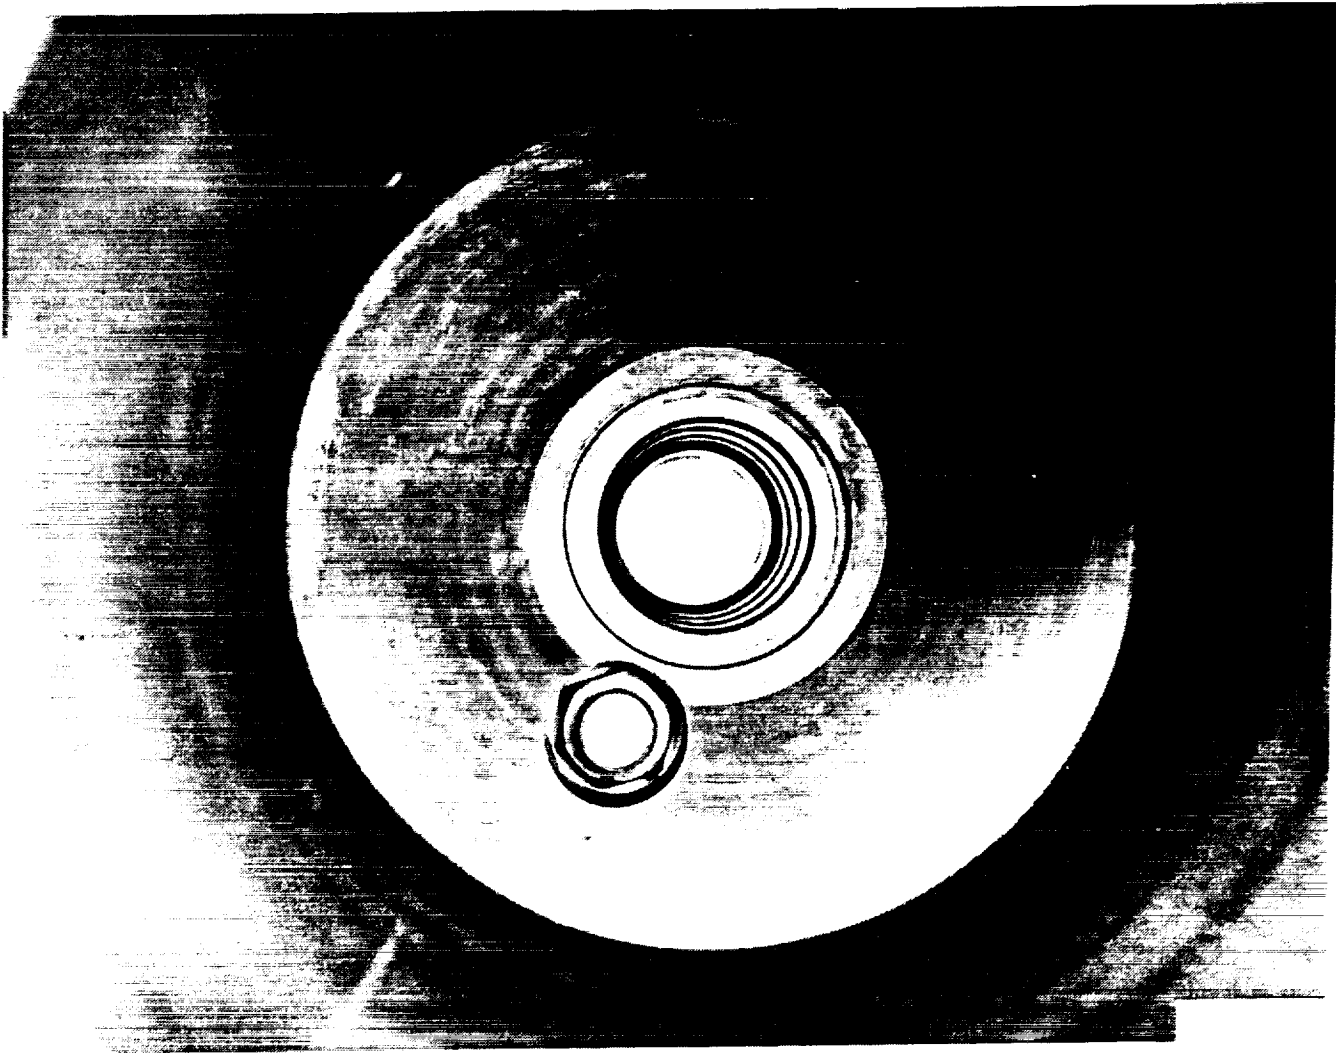
Figure 26.- Outer housing (-9).

Figure 27.- Outer housing (-9).
